> Railway Safety
Performance
in Ireland 2019

The Commission for Railway Regulation is pleased to publish its Annual Safety Performance Report for 2019. This report supplements the CRR's Annual Report to the Minister and provides further detail on the safety performance of the railway organisations operating in Ireland.

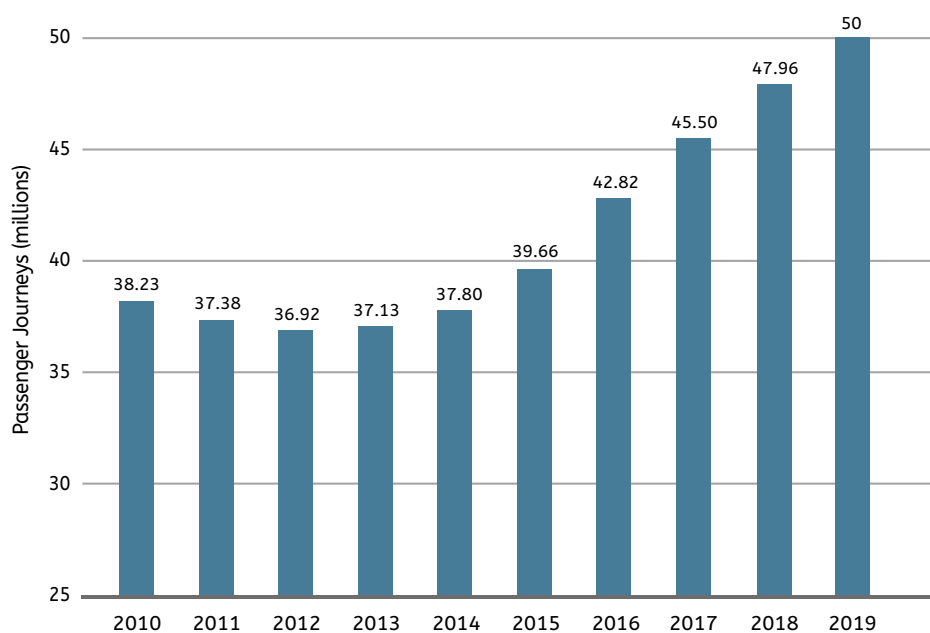
Figure 1: IÉ Passenger Journeys 2010-2019

Passenger journeys increased by approximately 4% on the 2018 figure to 50 million (Figure 1) which is the highest passenger journey figure in the company's history.

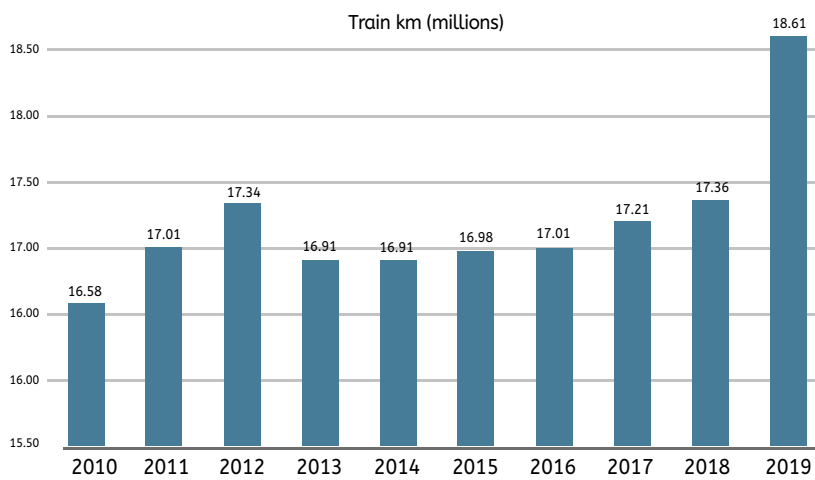
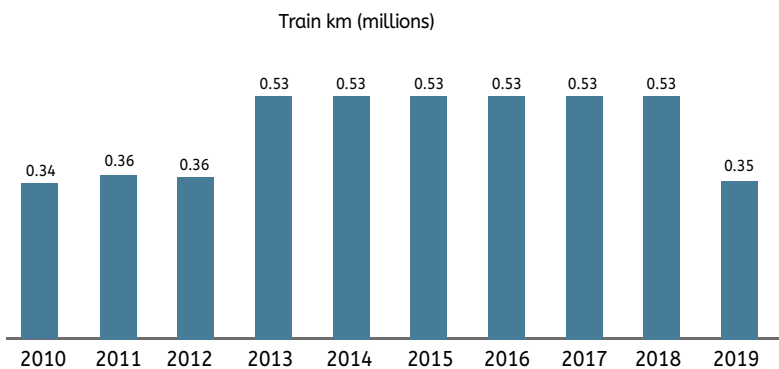
Figure 2: Passenger Train-km (top) Freight Train-km (bottom) on the IÉ-IM Network

Figure 2 shows that IÉ-RU passenger train kilometres increased by approximately 6.7% which is consistent with additional train services offered in 2019 and also reflects the increase in passenger journey growth (4%). Many trains are operating near capacity and the CRR have been advised that the fleet is fully deployed and there are no additional carriages available at this time to increase capacity at present.

Freight kilometres have remained stable since 2013 but saw a decrease in 2019 and this was in part due to the Tara Mines to Dublin Port service being curtailed for 4 months due to port infrastructure upgrade work and the cessation of container traffic (the DFDS contract) between Ballina and Waterford in 2018.

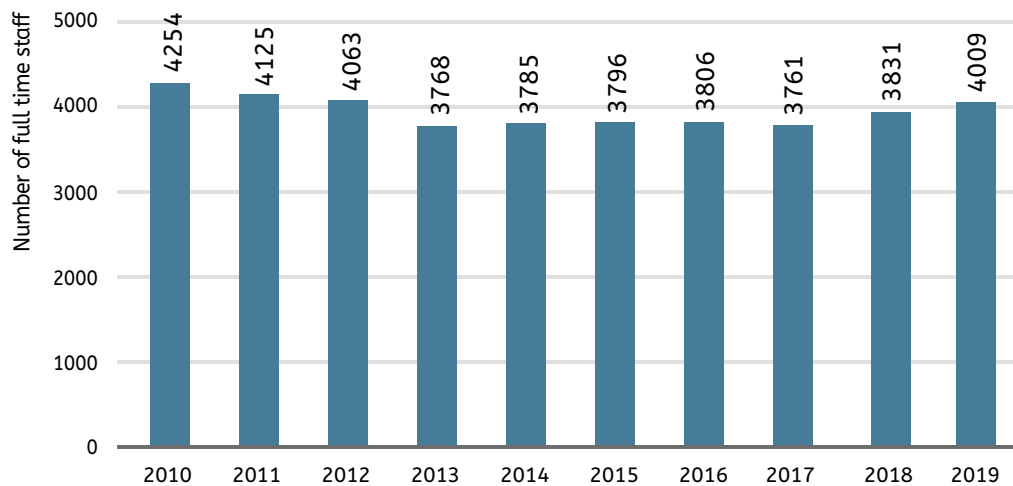
Figure 3: Personnel engaged in full time employment with IÉ (2010 – 2019)

In last year's report it was stated that Iarnród Éireann would likely need to recruit additional staff, primarily to the train driving grade given the increased rail traffic. This was borne out in 2019 with employee numbers increasing by approximately 4% (Figure 3). With new infrastructure and rolling stock projects in the pipeline,

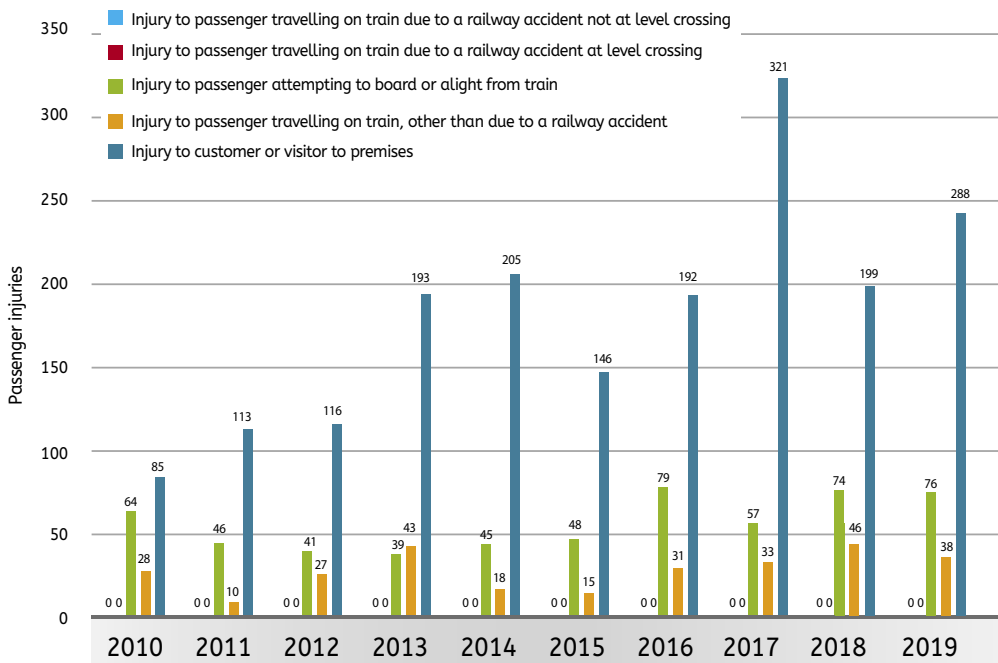
Figure 4: Passenger Injury Statistics by year

As reported in previous years, the data indicates that the largest proportion of incidents occur to persons during time spent at stations as opposed to time spent on trains and in 2019 this was no different. This trend is common across many railways in Europe.

Injuries to persons (customers or visitors) on railway premises remain at the largest single group with slips, trips and falls being the dominant cause of these injuries. There was a notable increase in injuries to customers and visitors to premises in 2019 compared to 2018 with a clear upward trend now visible (Figure 4). This is perhaps to be expected given there has been a steady increase in passenger numbers in recent years (Figure 1). The fact that the number of injuries to passengers attempting to board or alight from trains has remained broadly similar for the past 4 years against the backdrop of increasing passenger numbers is positive.

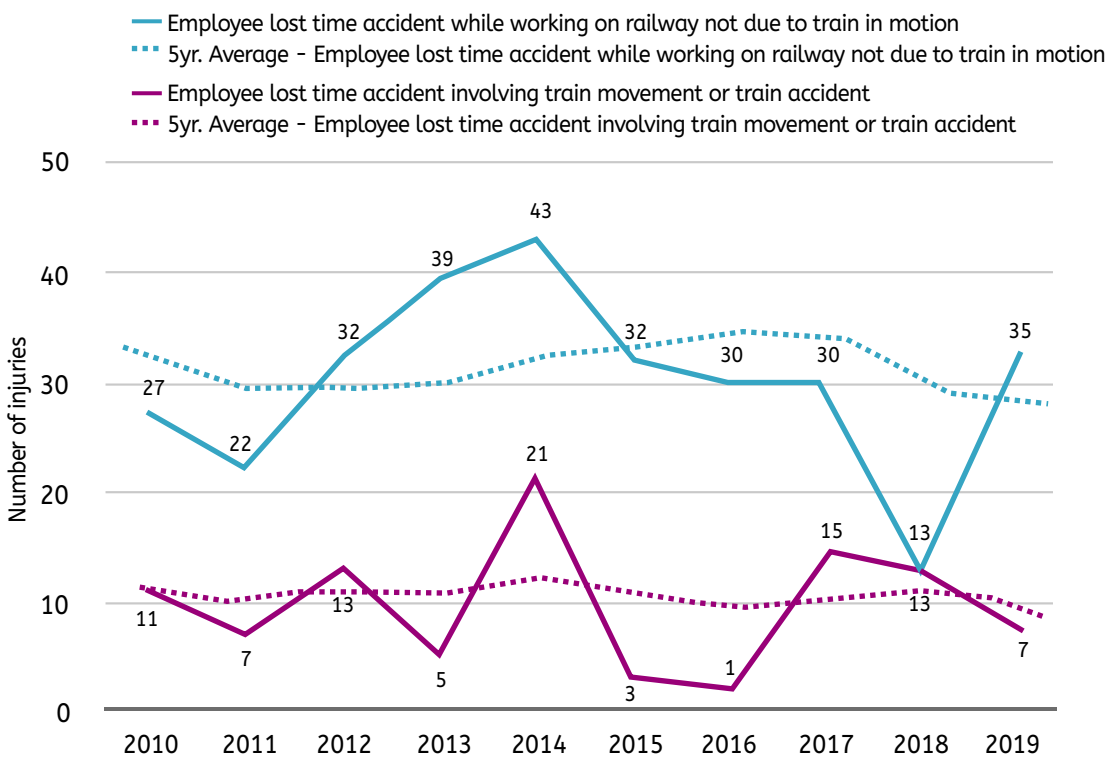
Figure 5: Employee Injury statistics by year (Railway Operations)

The figure for Lost Time Accidents (LTA) to persons, not involving moving trains was broadly in line with that in 2015 – 2017, but significantly higher than the figure for 2018. However comparison of the figures for the past 10 years does make the 2018 figure seem anomalous. This increase is to an extent offset by a continued decline in arguably the more serious accident category of LTA involving trains in motion, (Figure 5).

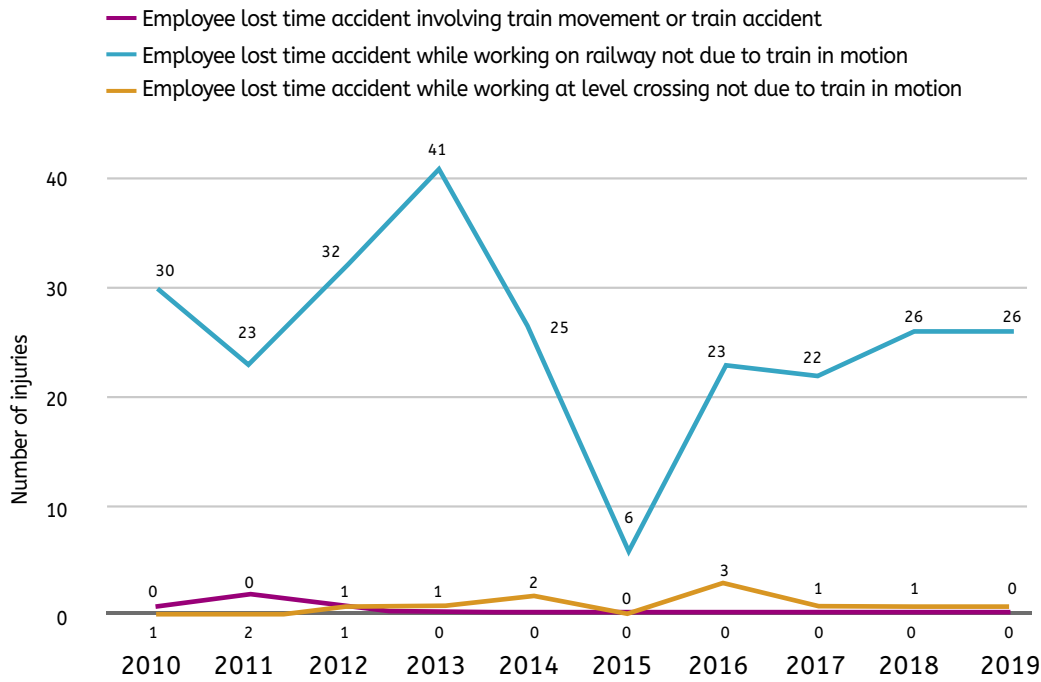
Figure 6: Employee Injury statistics by year (Railway Infrastructure)

The injuries to employees in the railway infrastructure sector remained unchanged in 2019 (Figure 6), with 26 Lost Time Accidents (LTA) to persons, not involving trains in motion, while the Entity in Charge of Maintenance (ECM) data shows a second year of

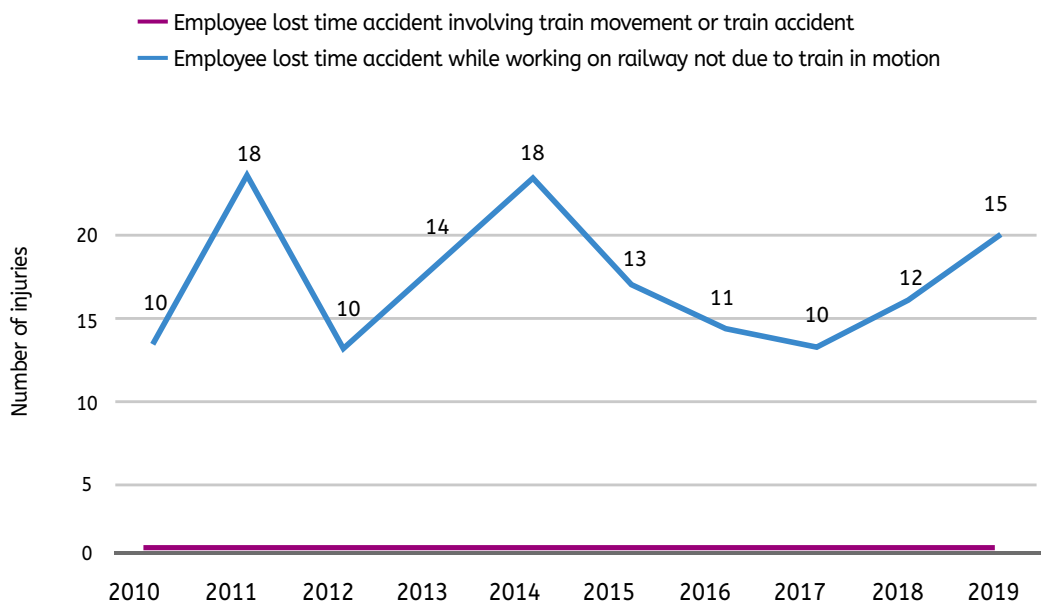
Figure 7: Employee Injury statistics by year (Railway ECM)

increasing accidents (Figure 7). The CRR were advised of an increasing number of LTA accidents involving staff with limited work experience, i.e., apprentices (Figure 7) but that additional safety measures, such as enhanced on-the-job monitoring, were being implemented.

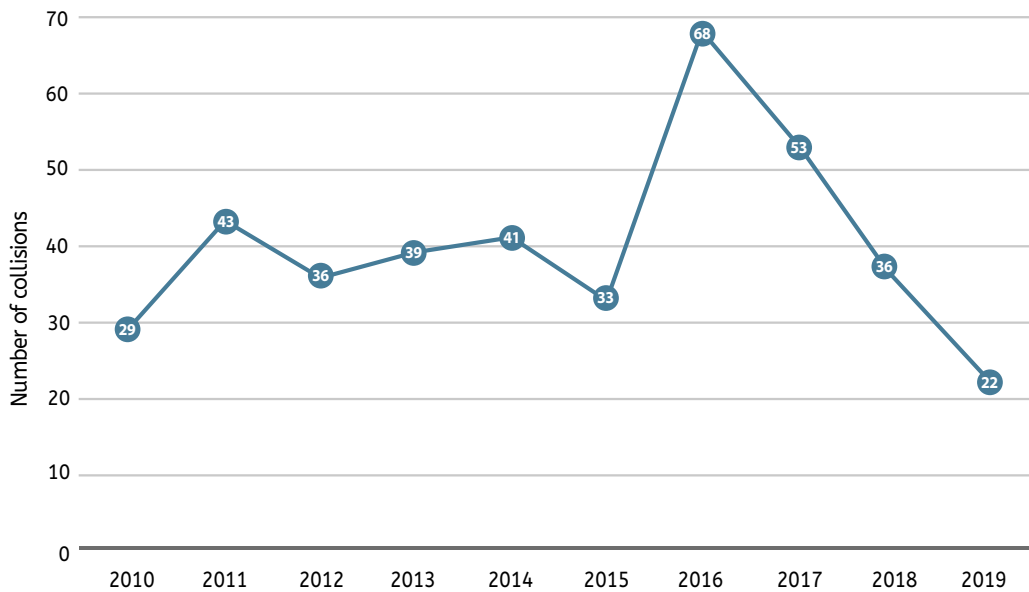
Figure 8: Total Collisions by year

Train collisions can pose a significant risk to passengers, train crew, third parties, and the environment. There are several categories of train collision, e.g., collision with road vehicles, with animals, with obstacle etc. Figure 8 illustrates the trend for collisions over the last 10 years.

Figure 8 is supported by Table 2 and Figure 9 to aid understanding of the data. In figure 9 two categories, 'Total Collisions with Obstacles on the line' and 'Train Collisions with large animals', have been separated to enhance understanding of the data. The overall data shows a continued decrease in collisions in 2019.

There has been some volatility in the data between 2013 and 2018, but since 2016 the trends are moving in a positive direction, i.e. collisions have been reducing with Table 2 showing that the in most categories the number of train collisions is zero or very low.

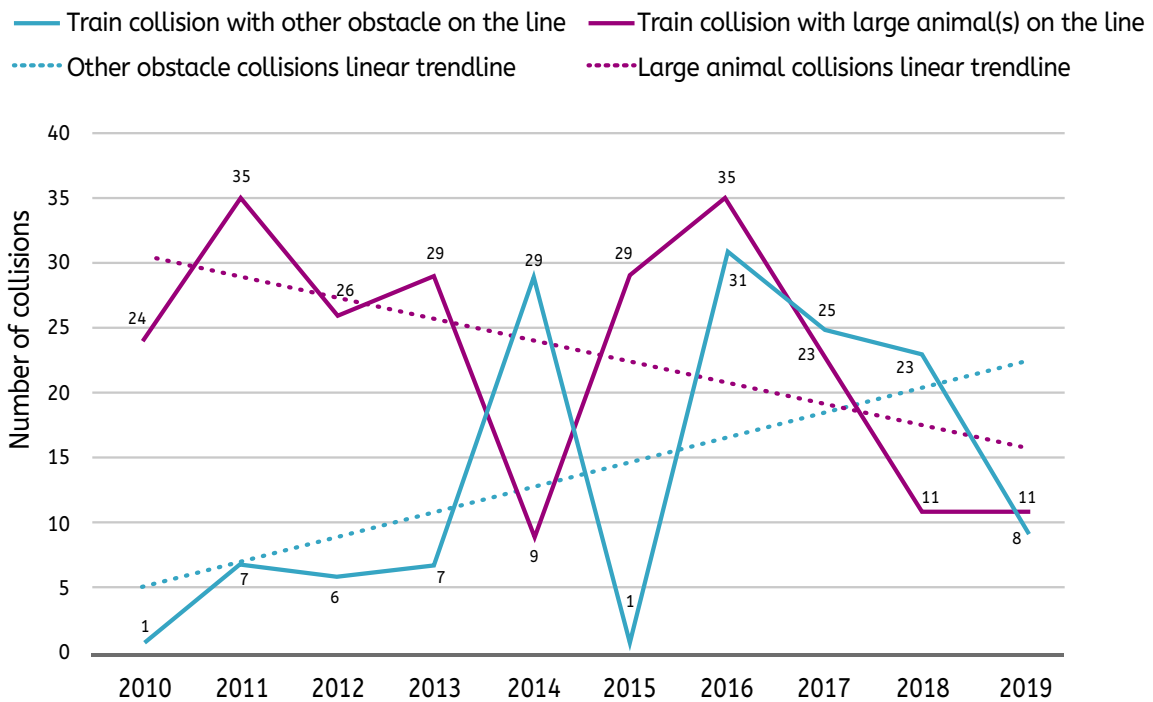
Figure 9: Train Collision Statistics detail by year, part 2

There are however two categories which have consistently been a cause for concern over the years. The number of collisions with 'other obstacle', typically trees/branches that fall onto railway lines following adverse weather, reduced in 2019 to a 4-year low of 8 events.

As discussed in previous reports, animals, (cattle, deer and to a lesser extent sheep) are a major contributor to collision statistics in Ireland and have the potential for serious consequences. There were 11 train collisions with large animal occurrences in 2019, the same as in 2018 which maintains the downward trend observed in recent years.

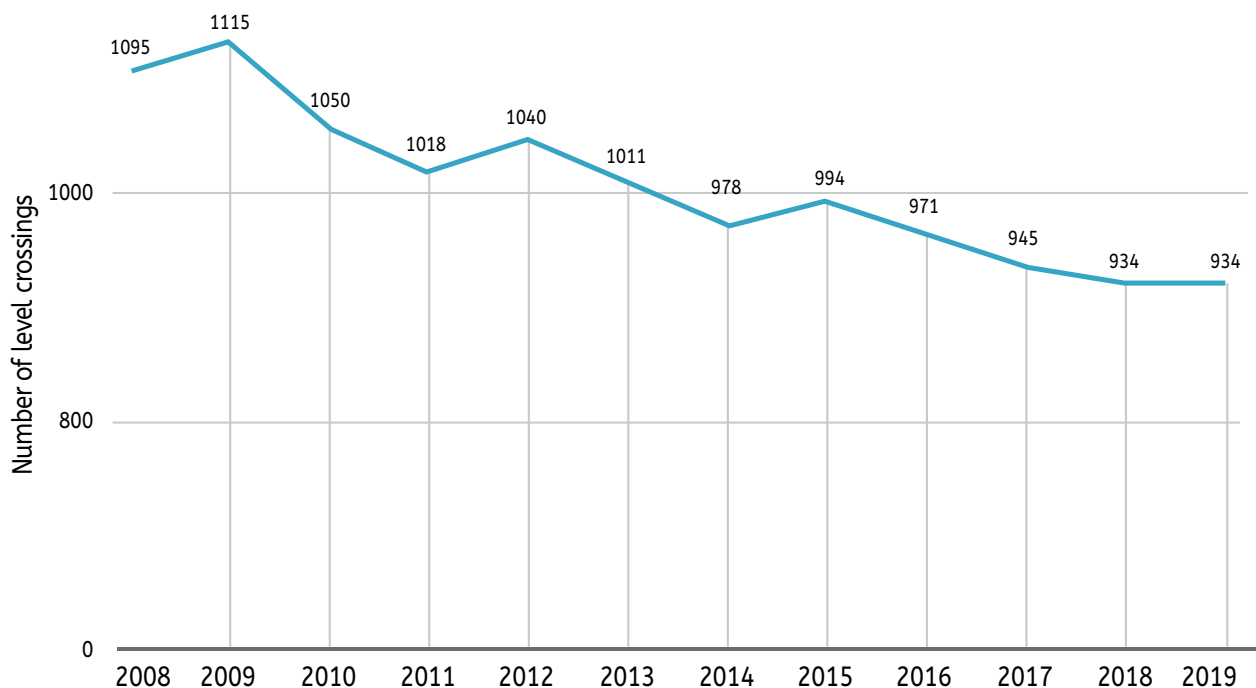
Figure 10: Number of level crossings by year

The long established trend, as shown in Figure 10 and Figure 11 is a decrease in the number of level crossings; there were 1701 level crossings in 2004 vs. 934 recorded for 2019. Figure 10 illustrates the number of level crossings on active lines. Sustained efforts by Iarnród Éireann have contributed greatly to reducing the risk presented by level crossings through closure or upgrade.

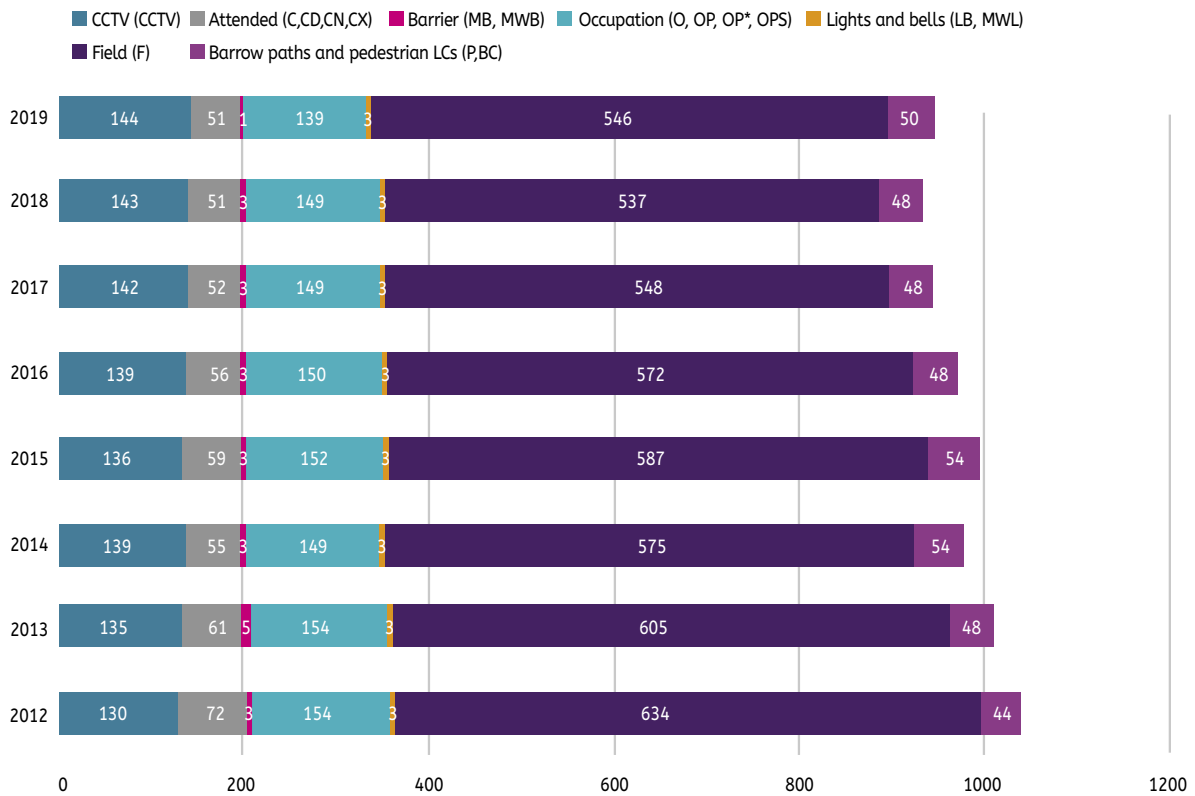
Figure 11: Level Crossing by type in Ireland

The breakdown of level crossings by type and year in Ireland is shown in Figure 11. Occupation level crossings on public roads, that is those that require the road user to manually open and close gates remain the highest risk type of level crossing, closely followed by passive 'Field type' level crossings which are those a farmer might use if they have land on both sides of a railway. The number of level crossings remained

the same in 2019 as in 2018 albeit there were a small number of designation changes. In 2019, Iarnród Éireann finalised plans to introduce a 'Decision Support System' at certain level crossings which is intended to improve safety and it is expected that a number of installations will be authorised to be placed in service/ commissioned in 2020. 8 Decision Support Systems were authorised and commissioned in 2020.

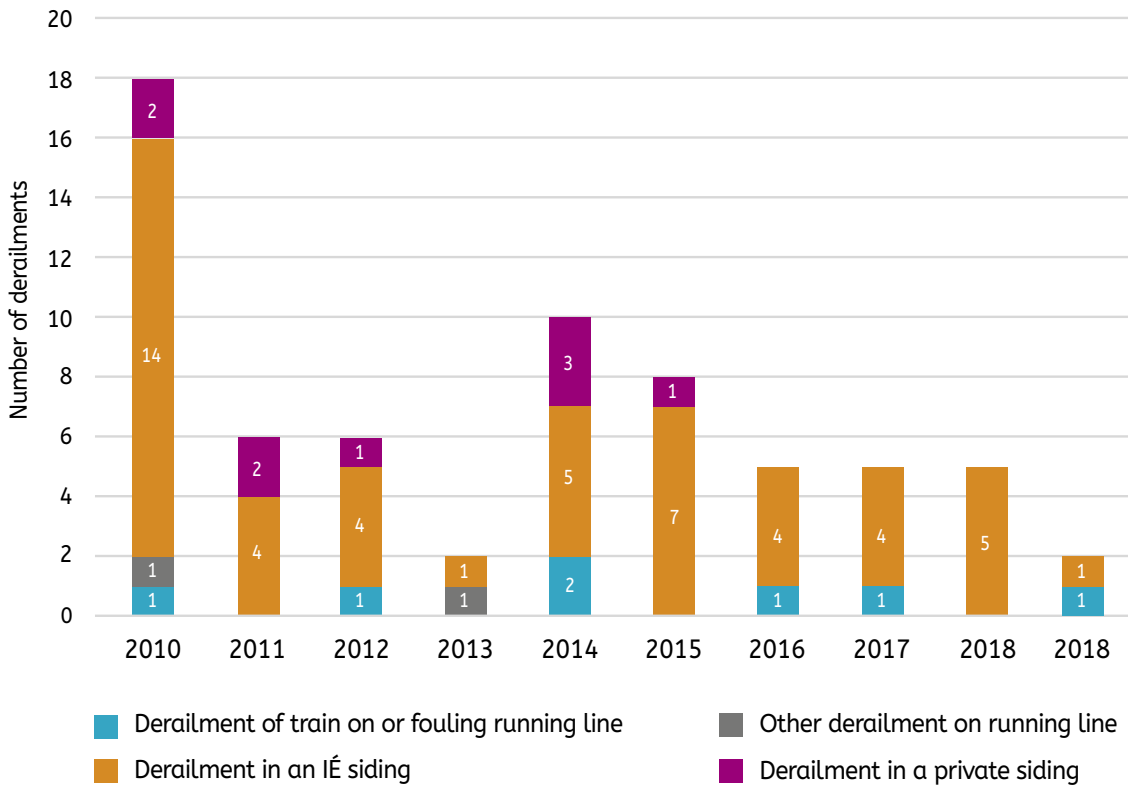
Figure 12: Train Derailments by Year

The number of train derailments reduced from 5 in 2018 to 2 in 2019 (Figure 12) with both involving IÉ-RU trains. The first of these took place in Portlaoise Traincare Depot and occurred to an Intercity Rail Car that was being moved, at low speed, from one line to another.

The immediate cause of the occurrences, as reported by the internal investigation reports, was, in the case of the Portlaoise derailment due to minor lapses of attention by railway personnel while in the of the Bray derailment the investigation concluded it was a culmination of factors including track geometry, train speed, rail head conditions etc.

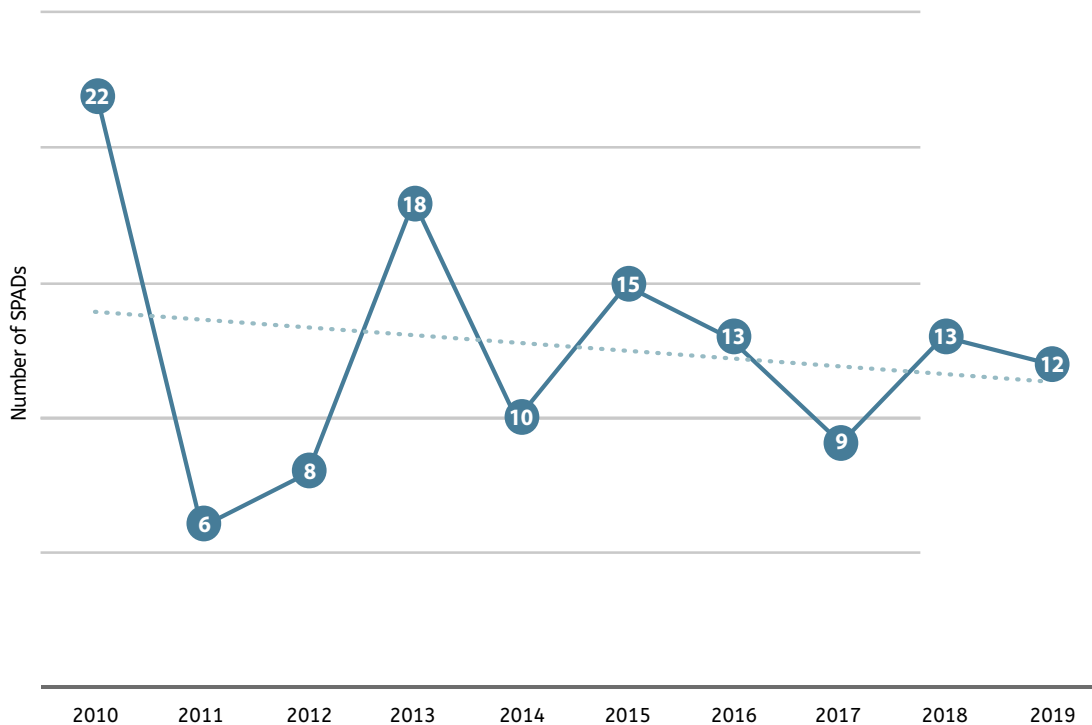
Figure 13: IÉ SPADs by year

A SPAD is defined as having occurred when a train passes a stop (red) signal without authority. SPADs are a particular precursor event that the CRR monitors regularly during its supervisory meetings with IÉ-IM, IÉ-RU and other mainline railway undertakings. The trend in recent years has been a steady decline; although data for 2018 was higher than the previous year but which again decreased slightly in 2019. (Figure 13).

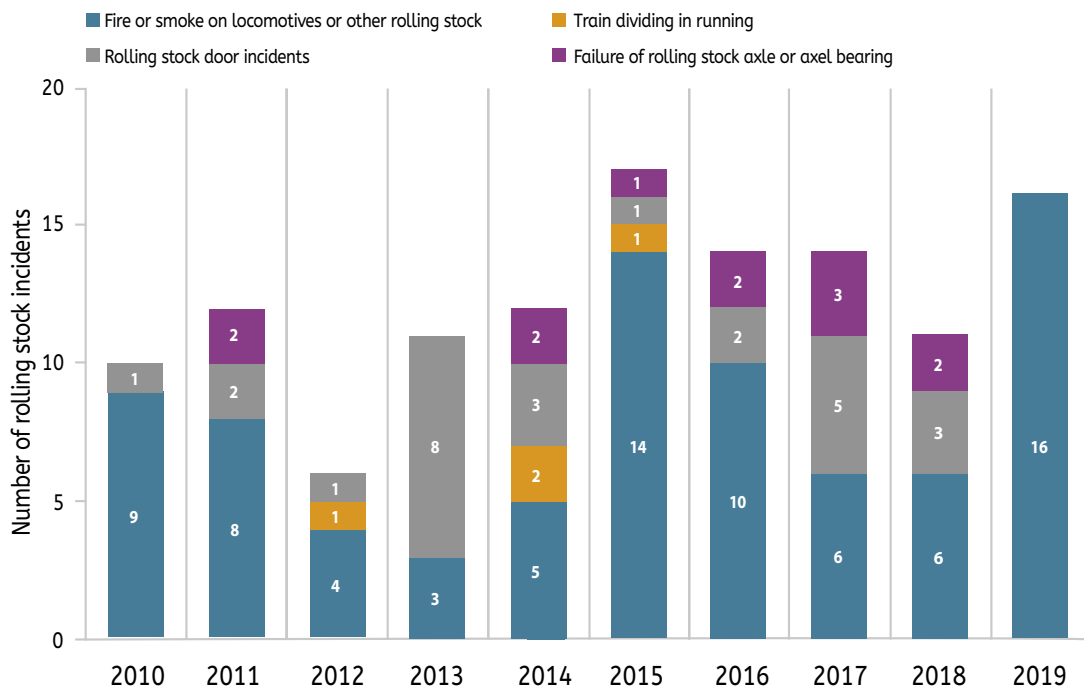
Figure 14: Rolling Stock Incidents by year

There are a number of key safety performance indicators pertaining to rolling stock (Figure 14), specifically:

- Fire or smoke incidents
- A train dividing (parting) while in service
- Failure of Rolling Stock Axle Bearing
- Door issues

Failures with rolling stock can potentially have very serious consequences. The number of reported occurrences increased in 2019 as may be seen (Figure 14). All reported occurrences (16) were in the fire/smoke category with 10 smoke (but no fire) events and 6 fire occurrences. Of the 6 fire occurrences 2 occurred on the 29000 fleet and 4 on the 22000 (ICR) Fleet. None resulted in injury and all were relatively minor being extinguished by the on-board fire suppression systems, with the exemption of 1 occurrence that involved a failed battery that led to a side panel detaching from an ICR near Heuston Station, Dublin. A number of fire suppression related safety initiatives were planned for 2020 by Iarnród Éireann which should see a reduction in the number of fire/smoke occurrences.

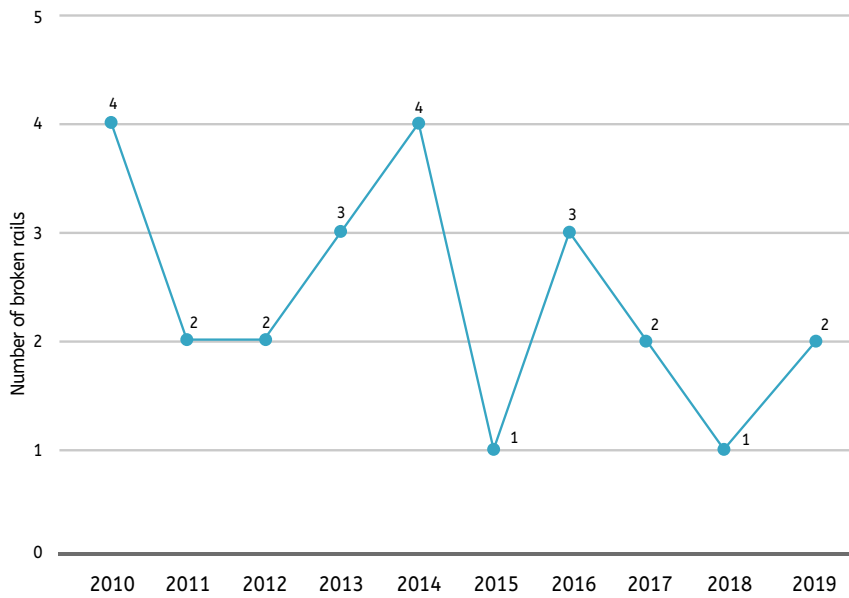
Figure 15: Broken Rails by year

ÍÉ-IM personnel visually inspect the track and associated assets at least once per week. Engineers and the Infrastructure Manager also inspect the track several times each year using a dedicated Inspection Car. The rails themselves are ultrasonically tested at least every 2 years, with the vast majority tested annually. In

2019, there were 2 broken rails both on the Dublin to Cork mainline and both discovered by track patrolling staff (Figure 15) maintaining the low incident rate of such events. Neither event resulted in a train accident, but it remains a high-priority for Iarnród Éireann – Infrastructure Manager to continue its rail renewals programme and to improve track formation through ballast cleaning and track stabilisation activity.

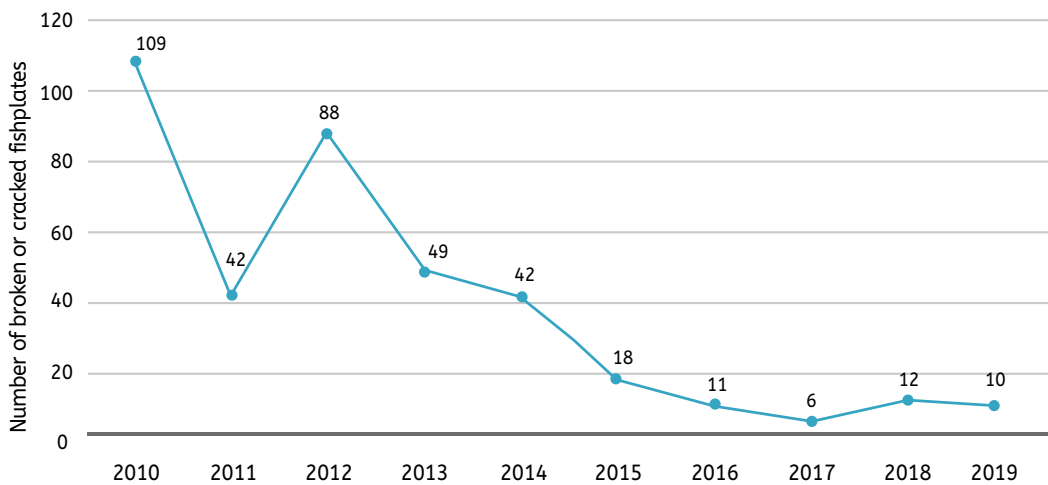
Figure 16: Cracked or Broken Fishplates on the IÉ Network, by year.

A fishplate is a special bolted connection that joins two rails together. Should one break then the rail is not continuous and could, in certain circumstances, lead to a derailment. The trend for 'Cracked or Broken Fishplates' has once more decreased in 2019 following a slight increase in 2018 (Figure 16). Numbers are now at a level that further reductions will be more difficult to achieve, rather continued vigilance by track inspection staff is needed to ensure they are identified proactively and repaired accordingly.

As has been noted in previous reports, the large decrease over the 10-year period may be attributed to the installation of continuous welded rail (CWR) initiated under the Railway Safety Investment Programme (1998-2013) which has continued since, albeit in smaller quantities.

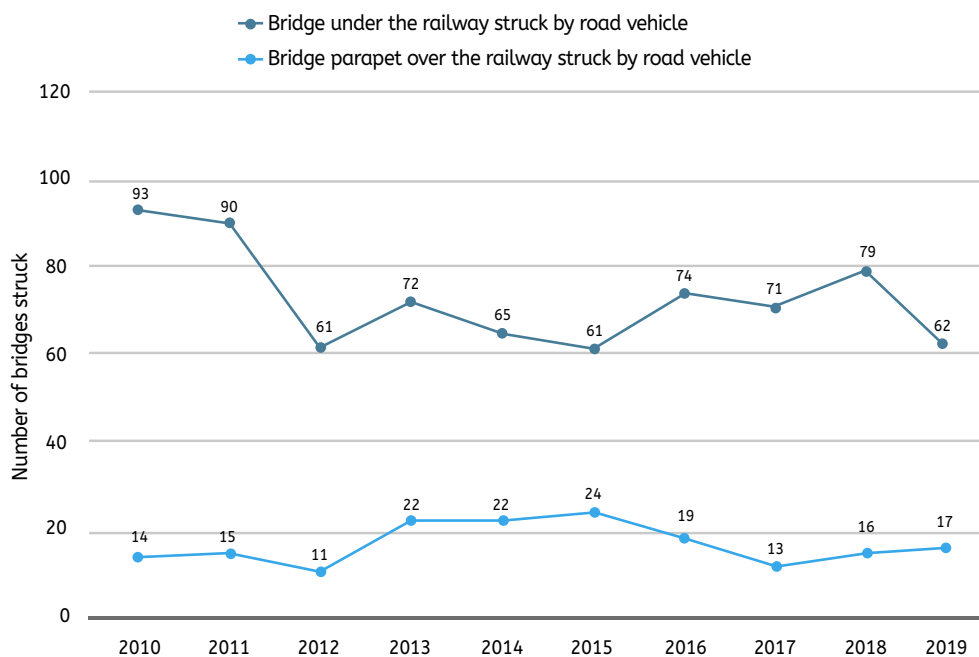
Figure 17: Railway Bridges struck by road vehicles

The total number of bridge strikes, i.e., both under-bridge and over-bridge, decreased by 16% in 2019 compared to 2018 (79 vs. 95 in 2018) with the decrease being attributable to the reduction in under-bridge strikes (Figure 17). Overall, the trend for both under-line bridges has been falling since 2010 while it has largely remained level for over-line bridge strikes.

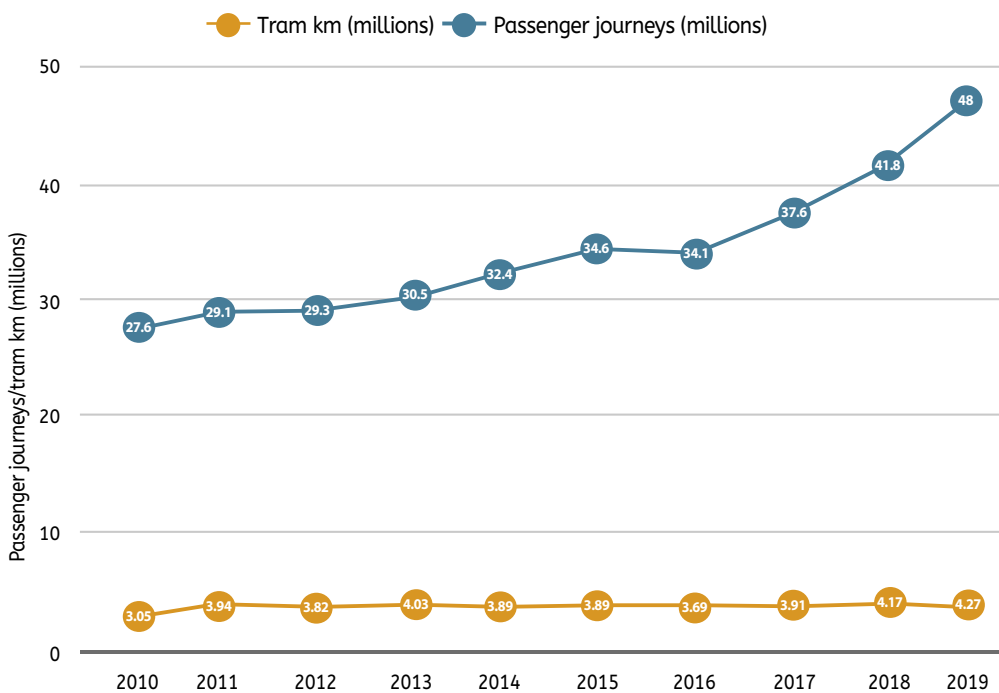
Figure 18: Luas passenger journeys & Tram-km travelled

Line, and a further addition of two newly extended trams brought into service in late 2019, (Figure 18). This continues the long-term trend for increasing passenger journeys, which has accelerated greatly in recent years.

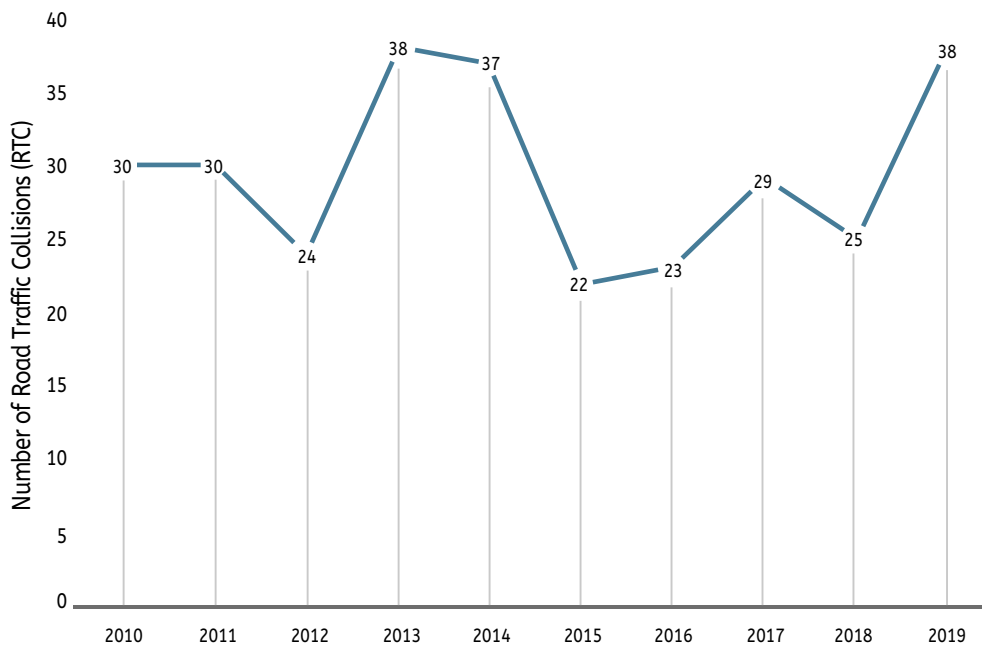
Figure 19: Number of Road Traffic Collisions involving a tram

The number of road traffic collisions has been on an increasing trend since 2015 and saw a significant increase in 2019, The 2019 figure rose by approximately 1/3 to 38 from 25 in 2018 (Figure 19). The increase was entirely attributable to the Red line, where collisions

increased from 17 in 2018 to 30 in 2019. Of the total number of collision (38), 21 were as a result if a road vehicle breaking a red light with the remaining 17 attributed to road vehicles infringing the trams swept path, that is the space swept out by the front and sides of the vehicle body, or any other part of the structure of the vehicle as it moves.
